SERVICE BULLETIN: JSB 040-2

Release Date: 19th December 2017

Subject: Jabiru Mechanical Fuel Pump

Affected Models: All engines up to S/No. 22A3811 & 33A2768.

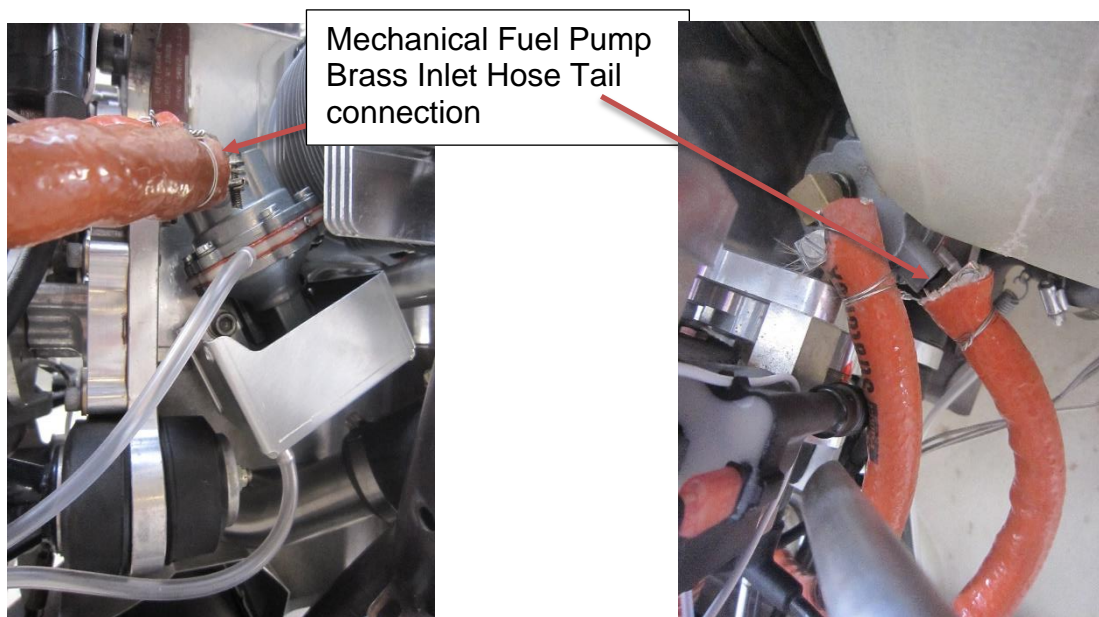
Figure 1 Mechanical Fuel Pump Brass Inlet Hose Tail location

- During routine maintenance a brass intake hose tail connection on a Jabiru mechanical fuel pump body was found to be loose.
- This service letter acts as a precautionary service message to inform maintainers and operators of this potential condition and prescribes an inspection to check that the brass intake hose tail connection is securely fitted to the body of the fuel pump.
- This service bulletin has been brought into effect as a means of assessing the prevalence of this condition in the Jabiru engine fleet.
- **Since the issue was discovered all new mechanical fuel pumps produced by Jabiru have screwed in brass hosetails to avoid this issue.**

- 1) Remove the aircraft cowl.
- 2) Locate the mechanical fuel pump (the position on engine is shown in Figure 1).
- 3) Inspect the brass fuel inlet hose tail to fuel pump body connection for security of attachment.

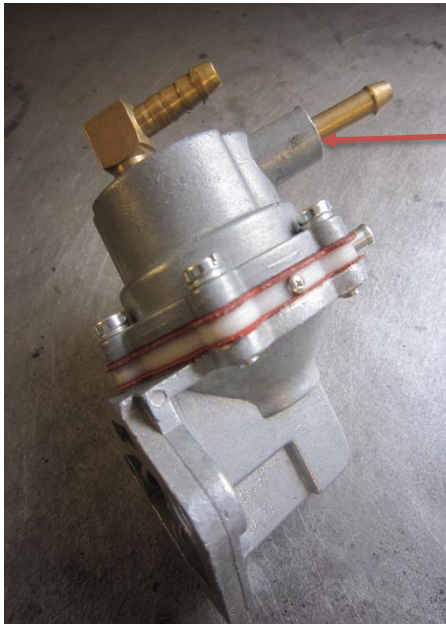
Figure 2 Mechanical Fuel Pump

Inspect the security of the fuel brass inlet hose tail in the body of the fuel pump

If it is found that the hose tail is loose in the body of the fuel pump, this condition must be corrected **before further flight**. Contact Jabiru Aircraft if this situation is encountered and complete a Continued Operating Safety Reporting Form that can be found at the following web address: http://jabiru.net.au/images/Owner_Operator_Responsibilities.pdf

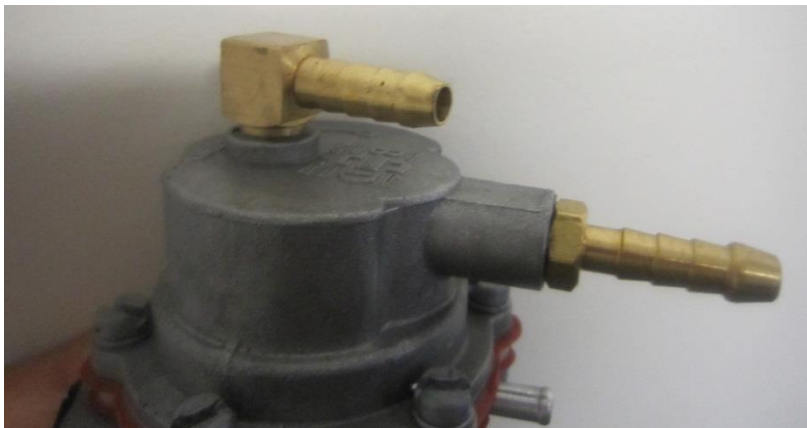
Figure 3: Pump with both fittings screwed in. (No further inspection required)
