Jabiru Service Letter: Valve Spring Washer Adverse Wear			JABIRU AIRCRAFT PTY LTD P.O. Box 5186 Bundaberg West Queensland, Australia. Phone:+61 7 4155 1778 Fax:+61 7 4155 2669 Email: info@jabiru.net.au		
JSL 008-1	Release Date: 21st Dec 2012	Effective Date: 21st Dec 2012	Affected Models: All	S/No. Range: All	Page 1 of 5

SERVICE LETTER: JSL 008-1

Subject: Valve Spring Washer Adverse Wear

Affected Models: All Jabiru Engines

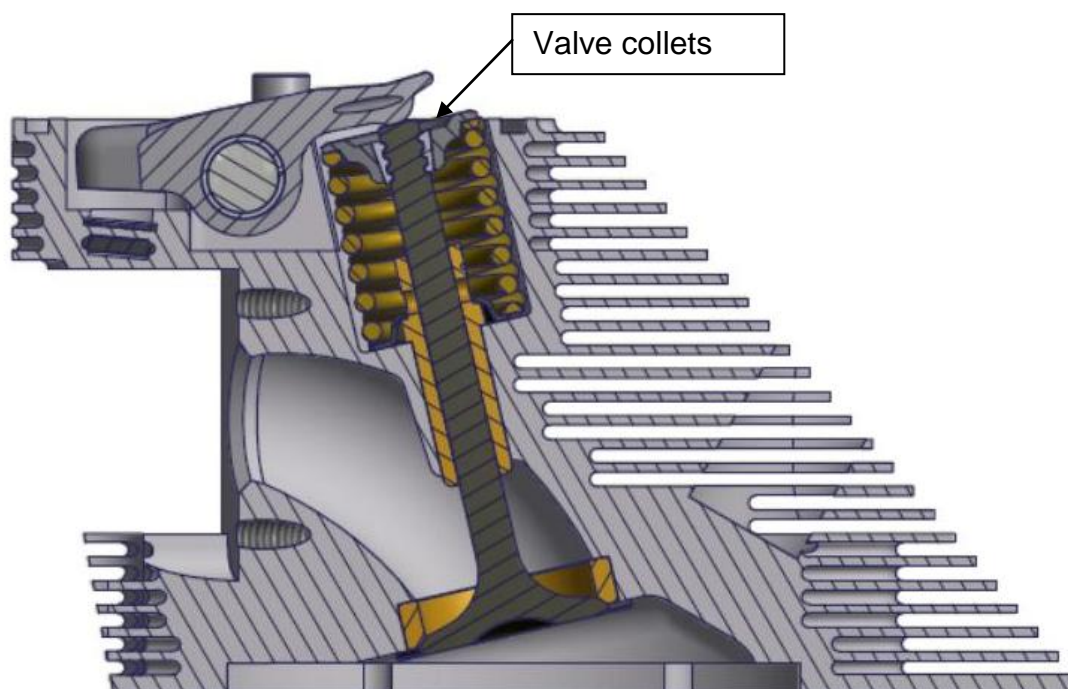
Figure 1 – Valve & Spring Cross Section

- Jabiru Engines use a conventional arrangement of washers and collets to retain the valve spring assemblies (Figure 1).
- By design the valves are free to rotate within the valve collets. The valve actuation mechanism applies a small rotational force to the valve, rotating it to maintain valve sealing.

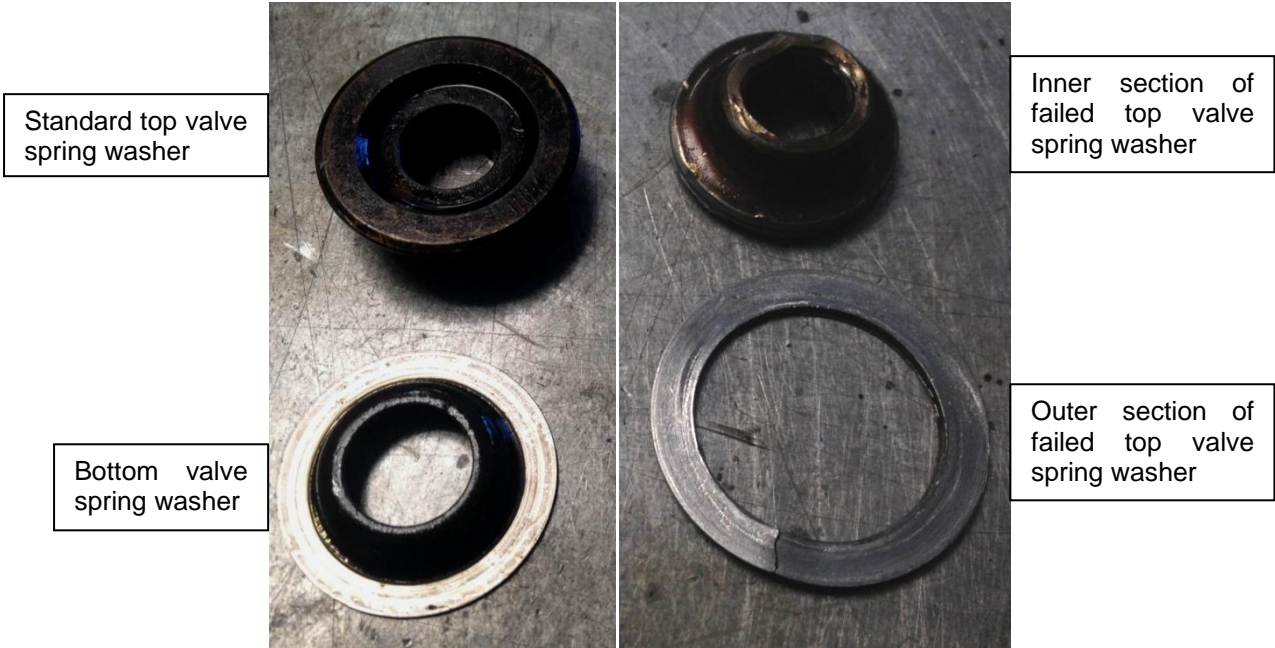
Figure 2 – Valve Spring Washers

- Two incidents, one year apart, have been reported to Jabiru Aircraft: in each a valve jammed in the collet, causing the top spring washer to rotate with the valve and wear against the valve spring, eventually causing a failure of the washer and engine stoppage.

- In both cases the engines were operated in dusty conditions and dirt contamination was found within the carburettor and intake plenum.
- It is likely that dirt contamination caused the valve to jam in its collets.

- Thoroughly inspect all valve washers and replace any which show signs of wear.
- Trial fit all valves to their collets and assess the fit before assembly; the valve should be free to rotate within the collet. While some friction is normal, binding or jamming is not acceptable. If friction is judged excessive the overhauler should try the valve in other collets and, if necessary, source replacement parts.

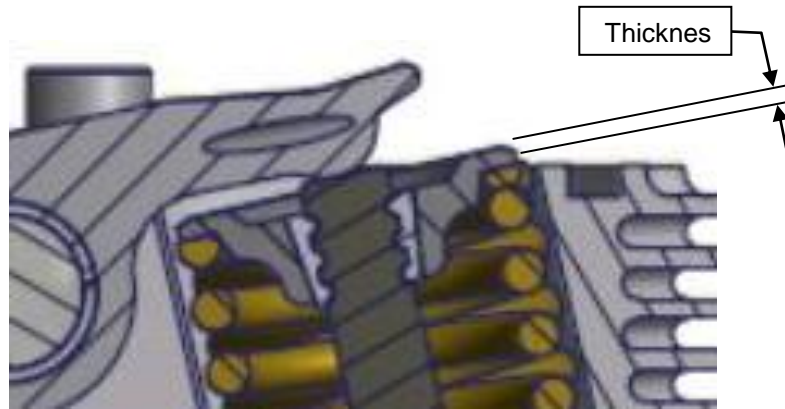
Figure 4 – Washer Thickness Measurement

- Visually inspect the top spring washer. A washer which is being worn may show burrs on the outer edge and the reduced thickness may be evident.
- The thickness of the top valve spring washer may be measured (Figure 4) using vernier calipers. Older washers should measure 1.5mm (0.060"), newer parts 2.0mm (0.08". 2mm thickness was introduced from S/No. 332486, 22A3514 and 22B263 and spare parts from June 2011). Any measurement below 1.3mm must be investigated and worn parts replaced; failure typically occurs at around 1.0mm.

Note: A depth vernier may be used for measuring a top spring washer in situ.

- Inspections per Section 3.4 are recommended during 50-hourly or Annual inspections whichever is the sooner.
