Jabiru Service Letter: Cylinder Head Inspection			JABIRU AIRCRAFT PTY LTD P.O. Box 5792 Bundaberg West Queensland, Australia. Phone:+61 7 4155 1778 Fax:+61 7 4155 2669 Web: www.jabiru.net.au Email: info@jabiru.net.au		
JSL 014-4	Release Date: 1 st July 2016	Effective Date: 8 th July 2016	Affected Models: See Applicability	S/No. Range: See Applicability	Page 2 of 17

LSA Service Notification: JSN 014-4

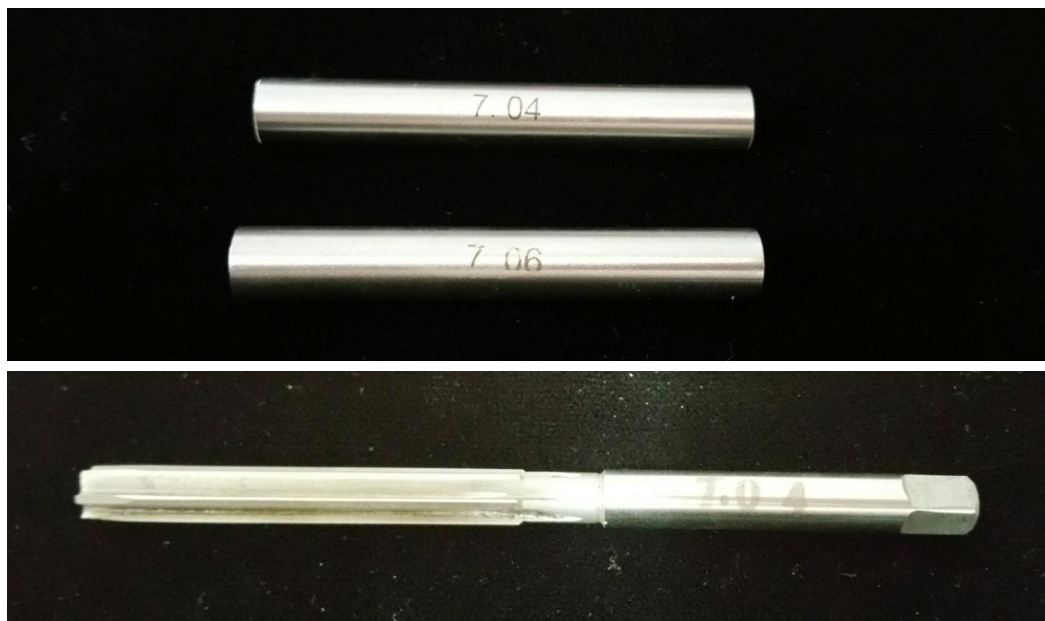
Figure 1: Valve guide Go-No go gauges and hand ream (available as a kit from Jabiru Aircraft)

- Inspect the valve guides. Check there is not excessive carbon build-up. Check the diameter of the guide is within the limits specified in the build tolerances table in JEM0001, using a 'Go-No Go' tool. Ream out valve guides if required to meet the tolerances specified in the Engine Overhaul Manual (JEM0001). **Go-No go gauges and the hand ream can be purchased as a kit from Jabiru Aircraft.**

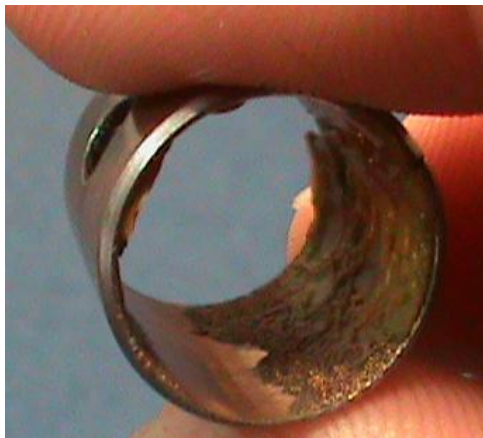
- Inspect rockers. In particular inspect the condition of the rocker bushes, check the bush for melting or other deterioration. Insert the rocker shaft and check that the rocker moves freely (but not loosely) on the shaft. Replace rocker bushes with new parts if required. In the photograph below the rocker bush has most of the inner lubricant material melted away. All yellow rocker bushes from all cylinder heads should be replaced. Report to Jabiru using Continued Operating Safety Form COSM-1 below.

Figure 3: Badly worn rocker bush.

- Rocker bush wear. May be caused by elevated head, oil or exhaust temperatures or high rpm on cold start up. Troubleshoot as noted above.

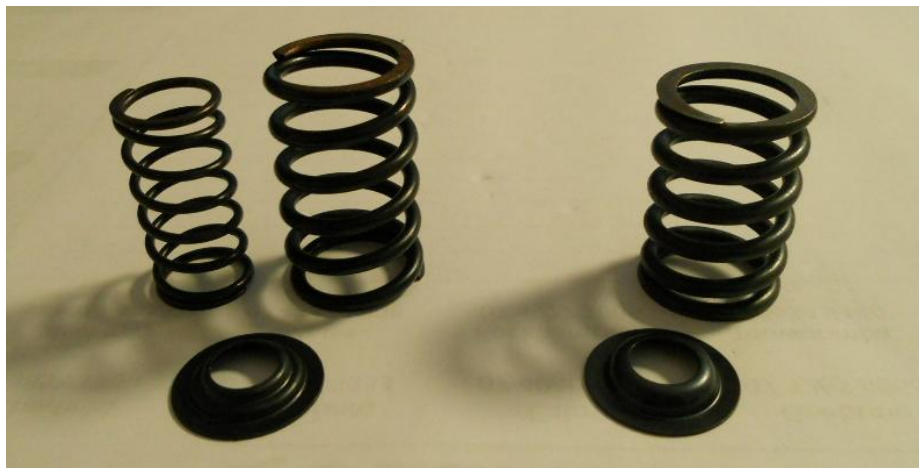
- After substantial design work and testing Jabiru Aircraft has released a configuration upgrade to the valve train. The double valve spring assembly.
- The double valve spring assembly features a small inner spring inside a larger outer spring, the coils are wound in opposite directions to prevent coil binding.

Figure 4 - New double valve spring vs the previous single spring configuration

- The valve seated pressure (i.e. valve closed pressure) is greater than for the single valve spring which can improve valve sealing. This can help prevent problems with compression and valve leakage which may contribute to preventing a valve failure. With a second spring there is now an element of redundancy in the system.
- Double Valve springs can be retrofitted into all Jabiru 2200 and 3300 engines. This upgrade is highly recommended for all engines.
- Upon inspection even if the condition of valves, springs or washers does not necessitate replacement, it is highly recommended that the double valve spring system be installed while cylinder heads are off the engine. In upgrading to double valve springs the following items must be replaced:

- Inner and Outer Valve Springs – replaces the existing single valve spring. **Do not install only the outer spring.**
- Bottom spring washer – The double valve spring assembly requires a specially stepped bottom spring washer with lands for both springs. Double valve springs should not be installed with the existing single spring washer.

- Top spring washer, collets and valves – Similarly the double valve spring assembly requires a special double stepped top spring washer. Since the top spring washer is being replaced the collets and valves themselves must also be replaced with pre-fitted hardware kits. The valves, collets and double land top/bottom spring washers are provided in the double spring inlet and exhaust valve kits.

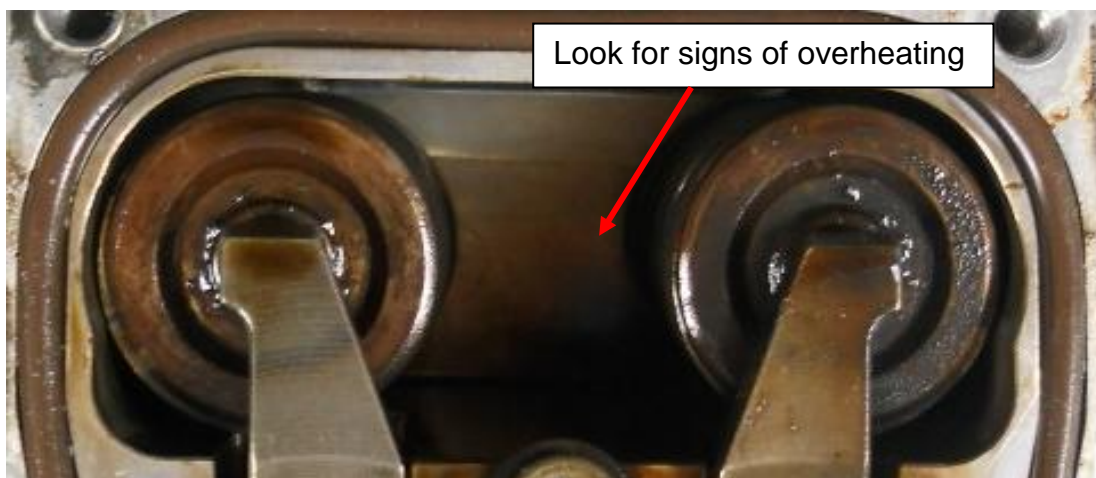
- Look for signs of overheating. If signs are present, proceed with **6.1 Cylinder Head Removal and Inspection**.
