**SERVICE BULLETIN: JSB 003-1**

**Subject: Jabiru J400/J200 Door Bolts**

Jabiru J400, J200, J430, J230, J450 and J250 models

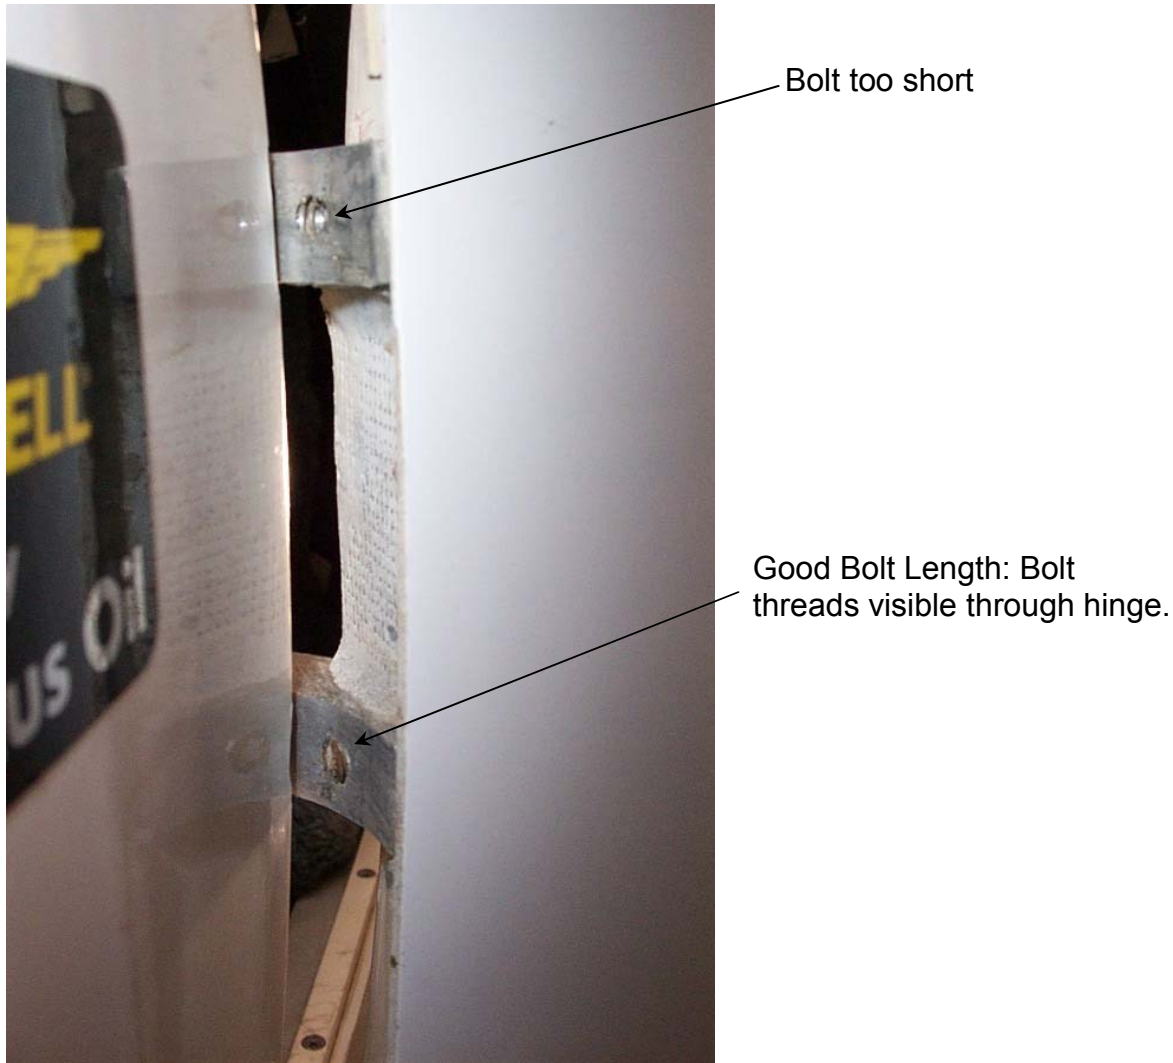
**Figure 1. Hinge Bolt Detail**

Some Builders of Jabiru J200/J400 series aircraft (All Jabiru Fuselages with 3 doors) have found that the bolts attaching the doors to the hinges are too short to positively engage the threads tapped in the aluminium hinges.

During the aircraft's next inspection, the hinges should be visually inspected. Refer to Figure 1 below.

If one or more of the attachment bolts are short, as shown in the top bolt above, they are to be replaced with a longer item. The attachment bolts are 1/4" UNC Socket Head Cap screws.
